# **Cyclone Seroja at the Yarragadee Geodetic Observatory**

## **- Preparation and effect**

**Randall S. Carman (1)**

(1) Geoscience Australia, Australia ([Randall.Carman@ga.gov.au](mailto:Randall.Carman@ga.gov.au))

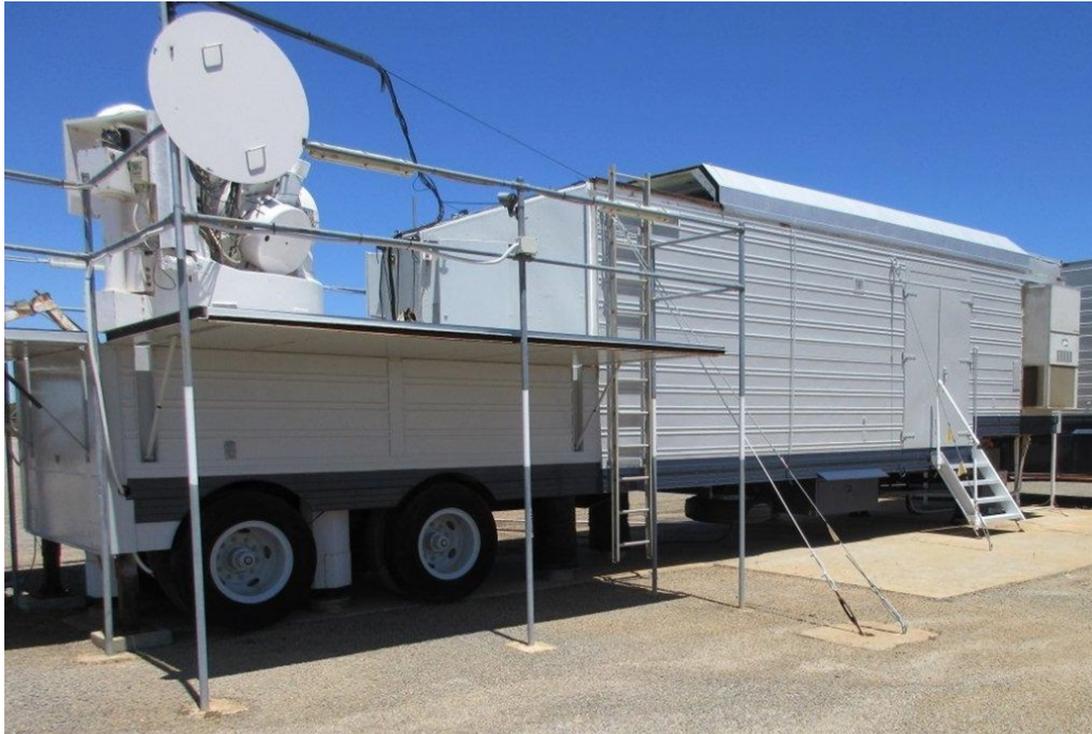
At Yarragadee, we checked and tightened all tie down cables and replaced any defective or missing ones. Fortunately, we had concrete anchor points installed because of previous cyclones in the late 70's. The two NASA vans were well tethered in all directions except for the MOMS van to the east (see figure 2). As for the VLBI dish, it was decided we did not have time (an elevated work platform would be needed) to tie the 12m main reflector to its anchor footings. Since the dish was designed to withstand 168 kph winds in stow, untethered, and the cyclone was expected to weaken rapidly once it crossed the coast, we felt our preparations were sufficient.

**Figure 2: Tie down cables secured (and new ones added), prior to impact.**

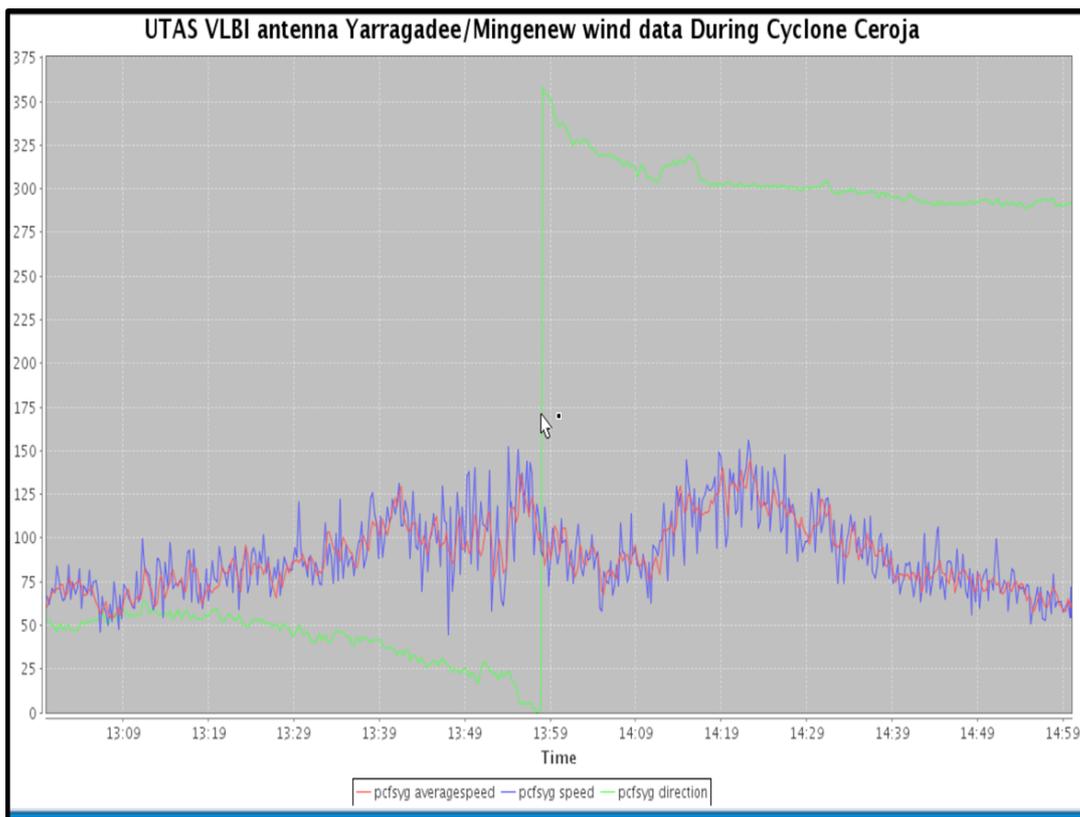
At around 2100 local, the cyclone crossed the coast and power and most communications went down at all staff homes. At that time winds at Yarragadee were a steady 70kmh. The Observatory continued to be monitored by the VLBI operations team at the University of Tasmania. The two anemometers on-site recorded a maximum wind gust of 162kmh sometime between 2125 and 2147 (see figure 4). At that time the operations building lighting circuit was tripped, most likely when the verandahs and carport departed. The eye of the cyclone passed over YGO from 2200-2215 after which, the winds increased dramatically again – back to around 160kmh. Fortunately, the cyclone was travelling abnormally quickly and wind gusts over 140kmh were only felt for about 25 minutes in total, which significantly reduced the risk of really extensive damage.

**Figure 4: Wind speeds recorded on YGO anemometer during cyclone Seroja**

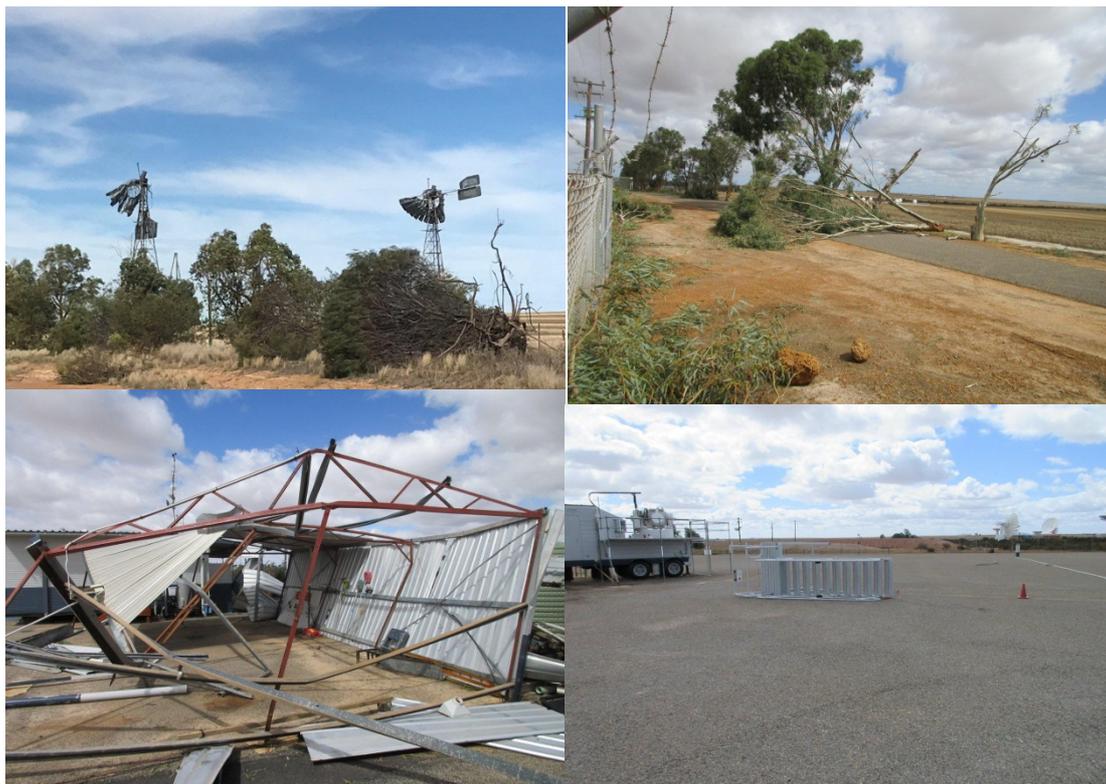
Access to YGO next morning was slow going, with many large trees having fallen across the road, especially as we got closer to the Observatory. The appearance of a lot of roofing sheets in the bushes and snapped power poles on approach didn't bode well. (See figure 5)

- Mains power out for 11 days (backup generator ok)
- 3 bay carport destroyed (see figure 5)
- Operations building verandahs gone – causing water to enter maser room
- Two sheds lost some roofing
- Gravity hut and VLBI shed had damaged timber framed walls
- Communications tower ( supporting anemometers) bent
- MOMS stairs, weighing about 400kg blown across compound (see figure 5)
- Perimeter fencing damaged
- MOMS van appeared to have moved slightly to the west

Figure 5: Damage at YGO and nearby was extensive      Credit R Carman and J Paff
